AVIATION INVESTIGATION REPORT A01P0171

LOSS OF SEPARATION AND RISK OF COLLISION

VANCOUVER AREA CONTROL CENTRE—NOOTKA SECTOR KELSY INTERSECTION, BRITISH COLUMBIA 23 JULY 2001

Report Number A01P0171

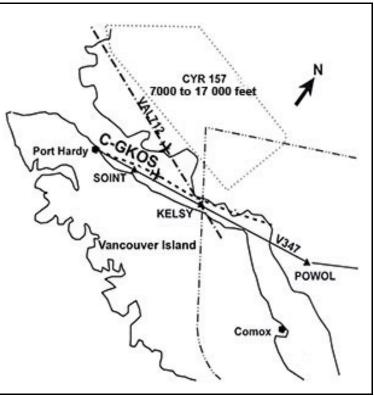
Figure 1. Relative flight paths of C-GKOS and VAL712

At 1351:50 Pacific daylight time,¹ when VAL712 and C-GKOS were about 1.7 nm apart at 17 000 feet, the Nootka radar controller (the radar controller), prompted by the Comox controller, recognized the imminent risk of collision. At 1352:05 and again at 1352:17, the radar controller tried to instruct C-GKOS to descend to 15 000 feet. However, he twice used the call sign GKS rather than GKOS, and the pilot of C-GKOS did not respond to those instructions. At 1352:21, he used KOS, and the pilot immediately acknowledged the instruction to descend. The radar controller did not advise either aircraft of the other. Radar data show that C-GKOS began to descend from 17 000 feet about 40 seconds after the first transmission to descend.

This incident occurred in the Nootka sector airspace (Figure 1), which is adjacent to military terminal airspace controlled by the Comox military terminal control unit at 19 Wing Comox.³ In this military terminal area, regulations require a minimum spacing between aircraft of 3 nm horizontally or 1000 feet vertically, but in the Nootka sector, 5 nm is required. A formal agreement between the Department of National Defence and NAV Canada further defines the responsibilities and the procedures applying to all aircraft transiting the two airspaces.⁴ In part, the arrangement requires that aircraft be separated by at least 5 nm when entering Comox airspace. In this incident, the required spacing between the two aircraft was not met and was unintentionally reduced to 0.8 nm at the same altitude.
